Submerged Cultural Resources Site Report

NOQUEBAY

APOSTLE ISLANDS NATIONAL LAKESHORE

**SUBMERGED CULTURAL RESOURCES SITE REPORT:
NOQUEBAY**

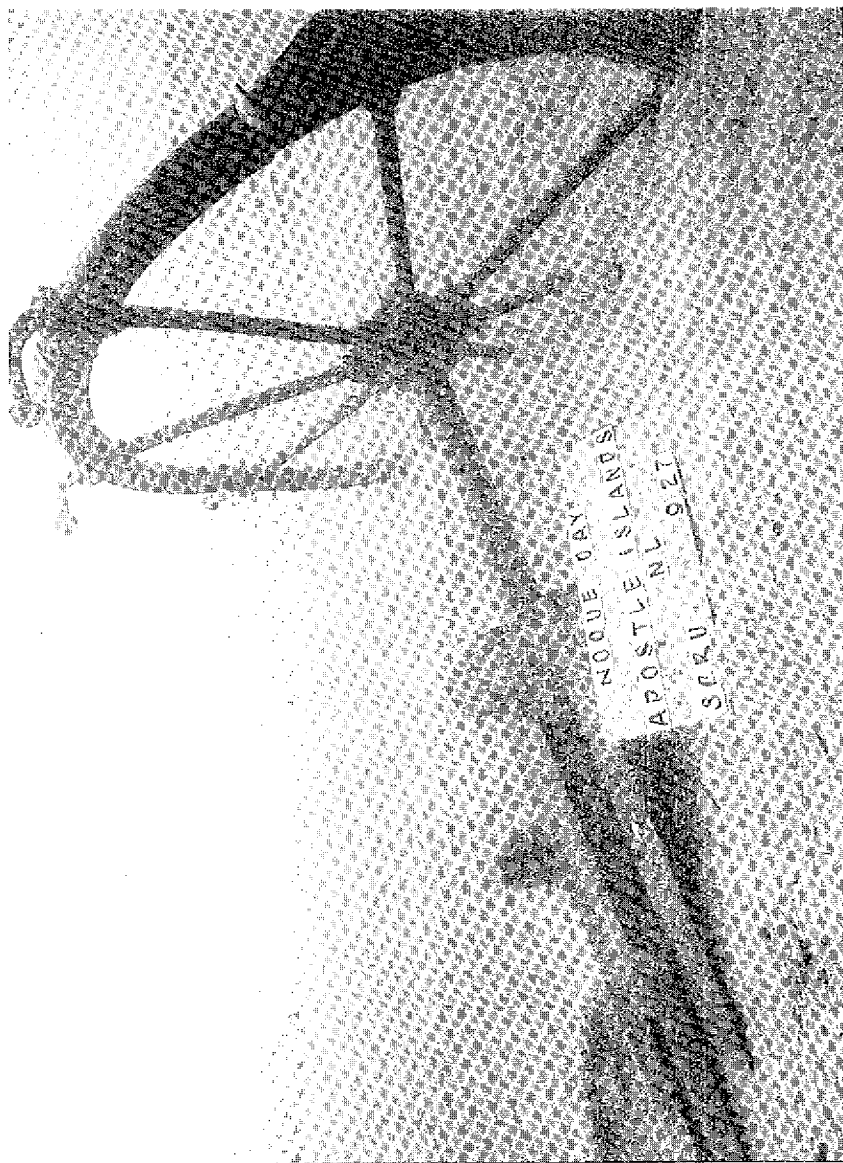
Plate 7: After excavation, the entire wheel and steering assembly were exposed. The mechanical, or "patent steering gear," came into use in the latter half of the 1800s. The wheel and worm gear are in an excellent state of preservation.

The mechanical steering gear and spindle (Figure 8), also called worm gear or screw gear, are made of steel or iron and are in an excellent state of preservation. The guide rods are in place as is the yoke and yoke bolt. The coupling rods are missing; however, the traverse nuts are in place. Only the cross head top plate was present. The spindle is 34-1/2 inches long, with 15 exposed right-left spindle threads at 1 per inch, and 8 exposed right-left spindle threads at 1 per 3 inches. The steering wheel spindle is 2-1/4 inches in diameter and it is 4 feet 4-1/2 inches long to the wheel. The overall length of the steering mechanism, including the wheel is 5 feet.

Following the mapping, photo, and video documentation of this feature, it was reburied. This was done to protect the wheel from winter storms, ice action, and possible vandalism.

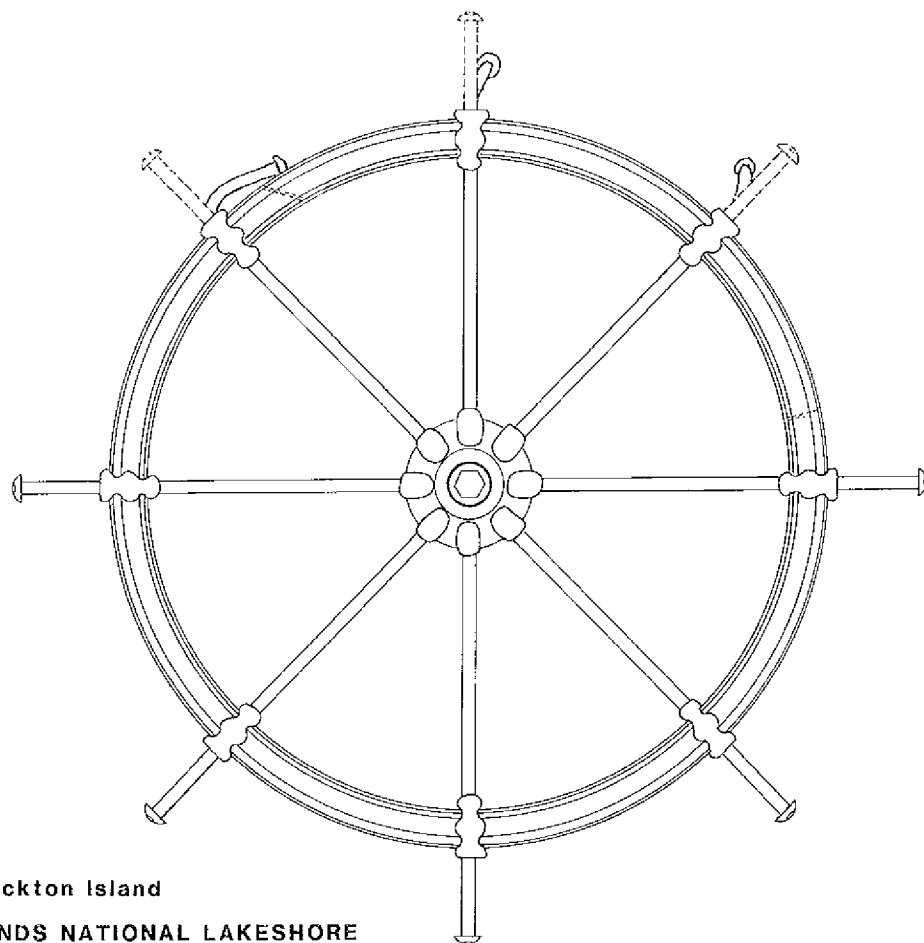
Figure 7: Ship's Wheel

the wheel is 4 feet 5 inches, while the 8 spokes each measure 22-1/2 inches overall (Figure 7). The spokes, center hub and hex nut are bronze; the wheel rim is steel. The spokes are 7/8 inch in diameter with a 1-1/2 inch cap. The center hub diameter is 8-1/2 inches overall with a 1-7/8 inch center hex nut backed by washers. The name of the manufacturer of the wheel and steering mechanism is still visible on the wheel rim; they are Coffin and Woodward, Boston, Massachusetts.

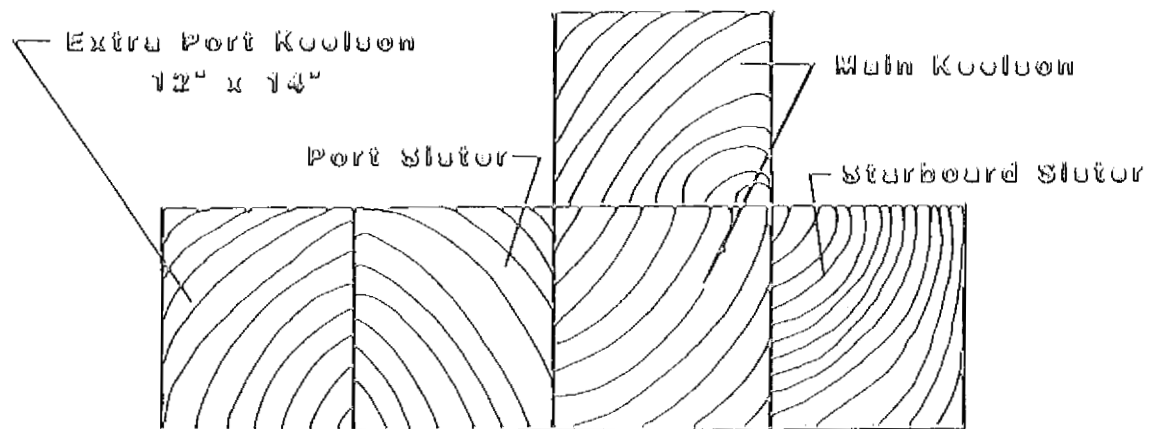
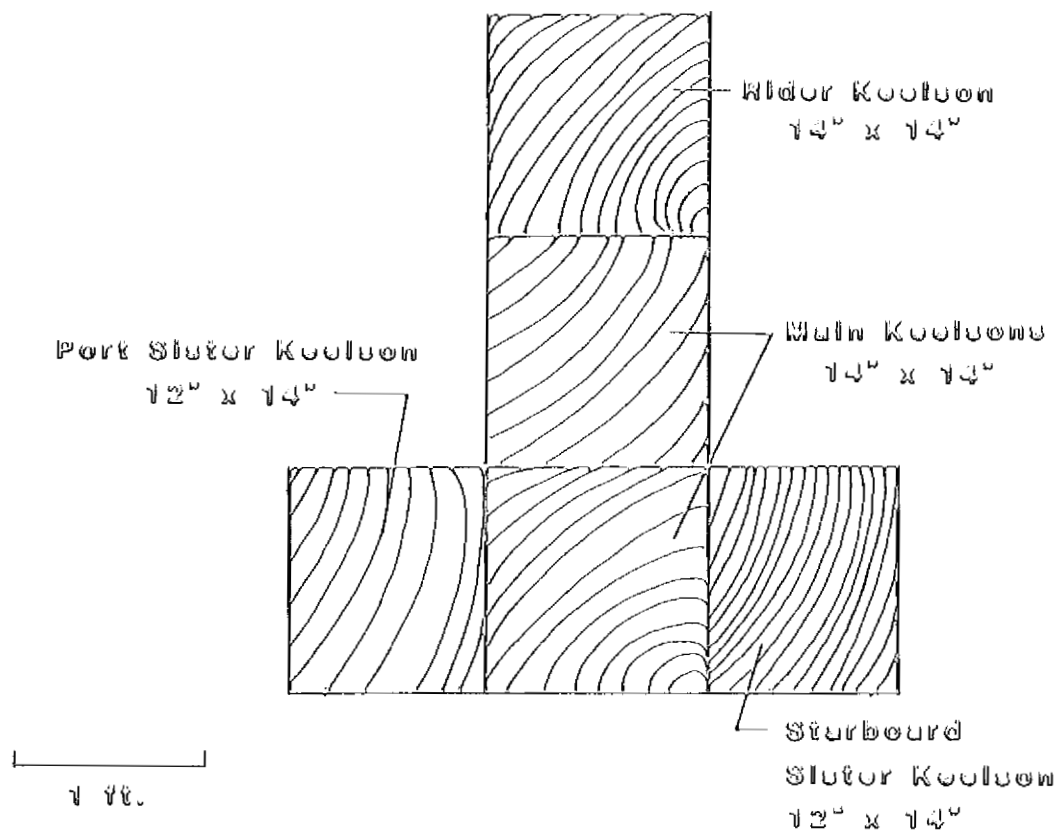
Figure 9: Centerline Keelsons Cross Section

The main keelson is composed of two stacked timbers, each 14 inches by 14 inches. The main keelson broke at a point of weakness, at the scarph in the stern. The scarph joint used on all of the keelsons is the same type, a hooked scarph. The scarphs found on the vessel are a uniform 5 feet in length. This followed the ship building rule of the era which called for making the keelson scarphs "equal to at least two frame intervals, that is double the room and space" (Desmond 1919:55).

The rider keelson, resting atop the main keelson timbers, is also 14 by 14 inches. A rider keelson is usually added to provide additional longitudinal strength. Its extant length on the vessel is 28 feet 6 inches. When the main keelson gave way, the rider apparently failed with it.

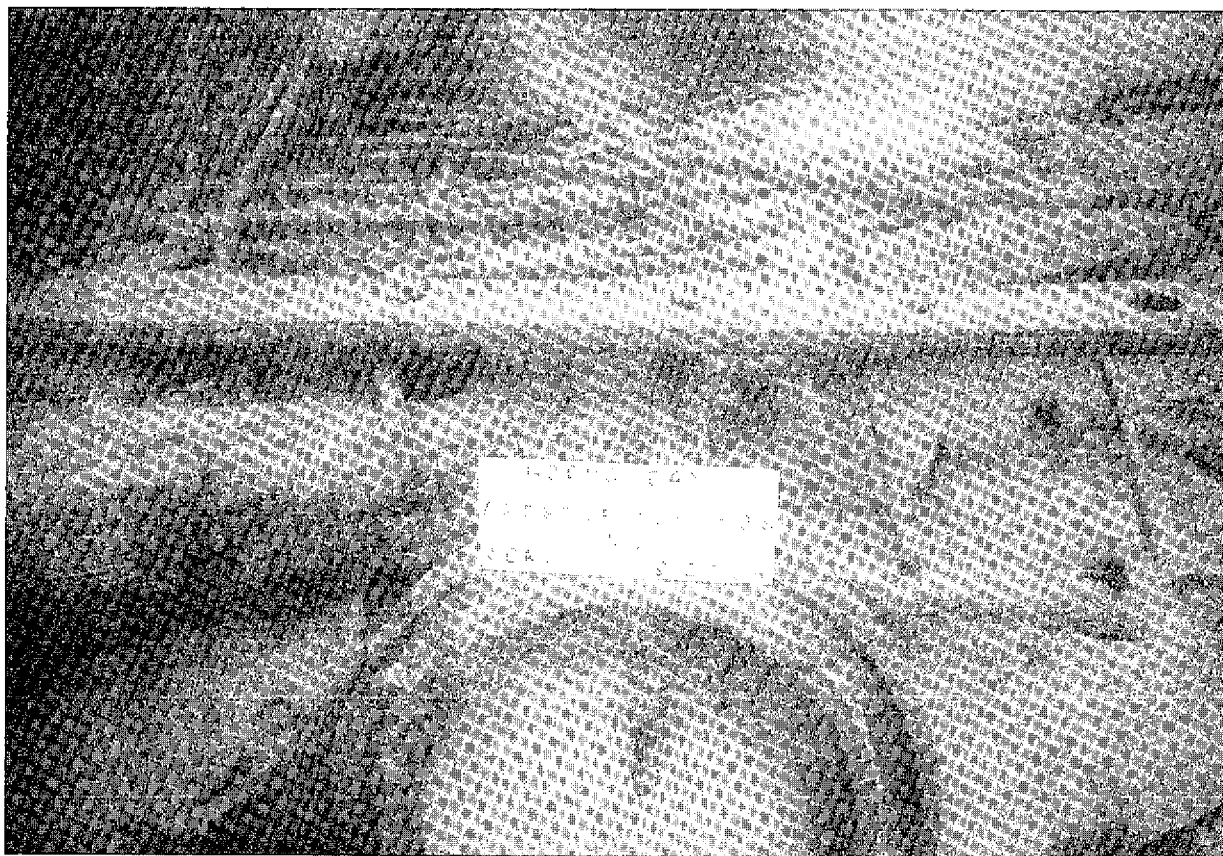
Plate 12: The bow deadwood, constructed of 4 stacked timbers each 16 by 14 inches, has two flat straps which straddle the timbers. These straps would have articulated with the truss rods as part of the vessel's hogging system. The driving wheel from the windlass is leaning up against the deadwood strap.

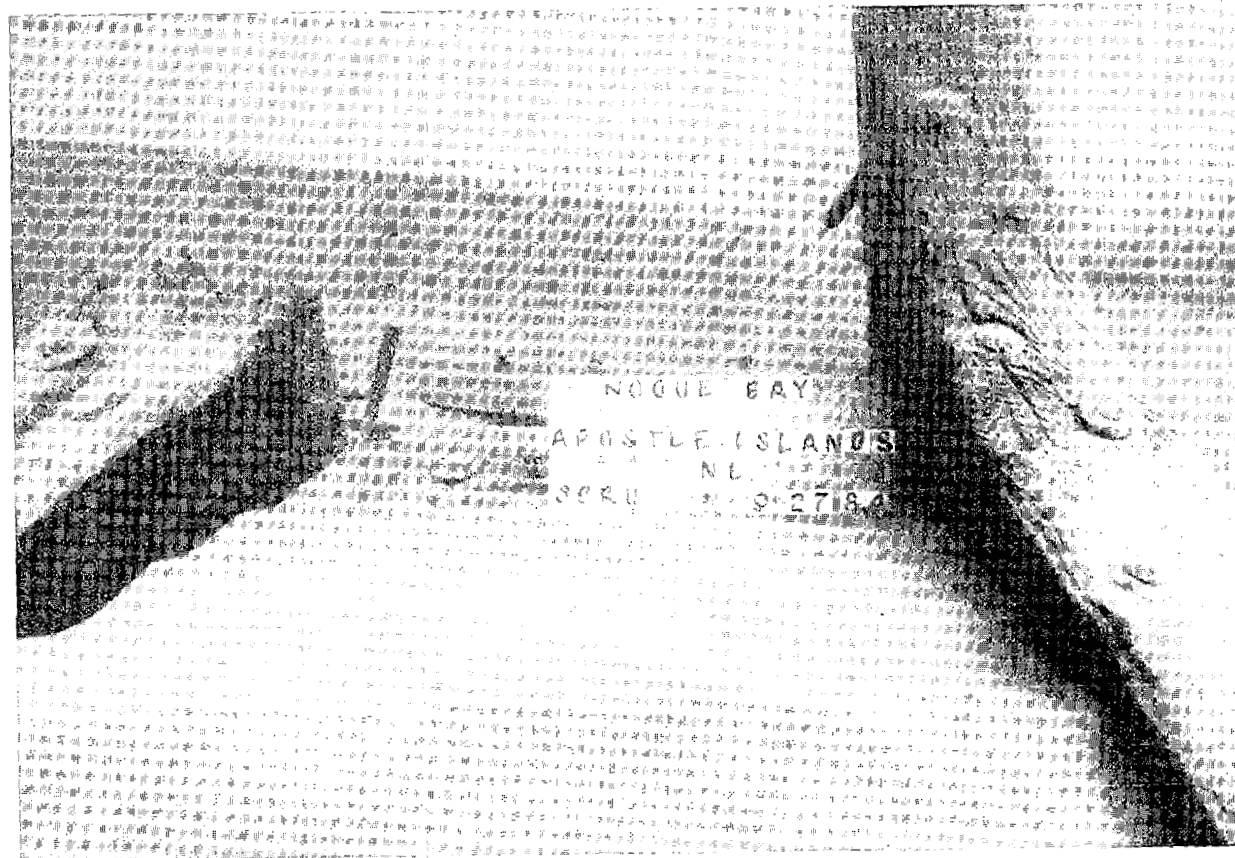
Plate 13: The hogging strap was directly tied into the deck beams and knees at the level of the main deck. Natural knees were used throughout the vessel. Fasteners through the knees are 7/8 nails with clench washers.

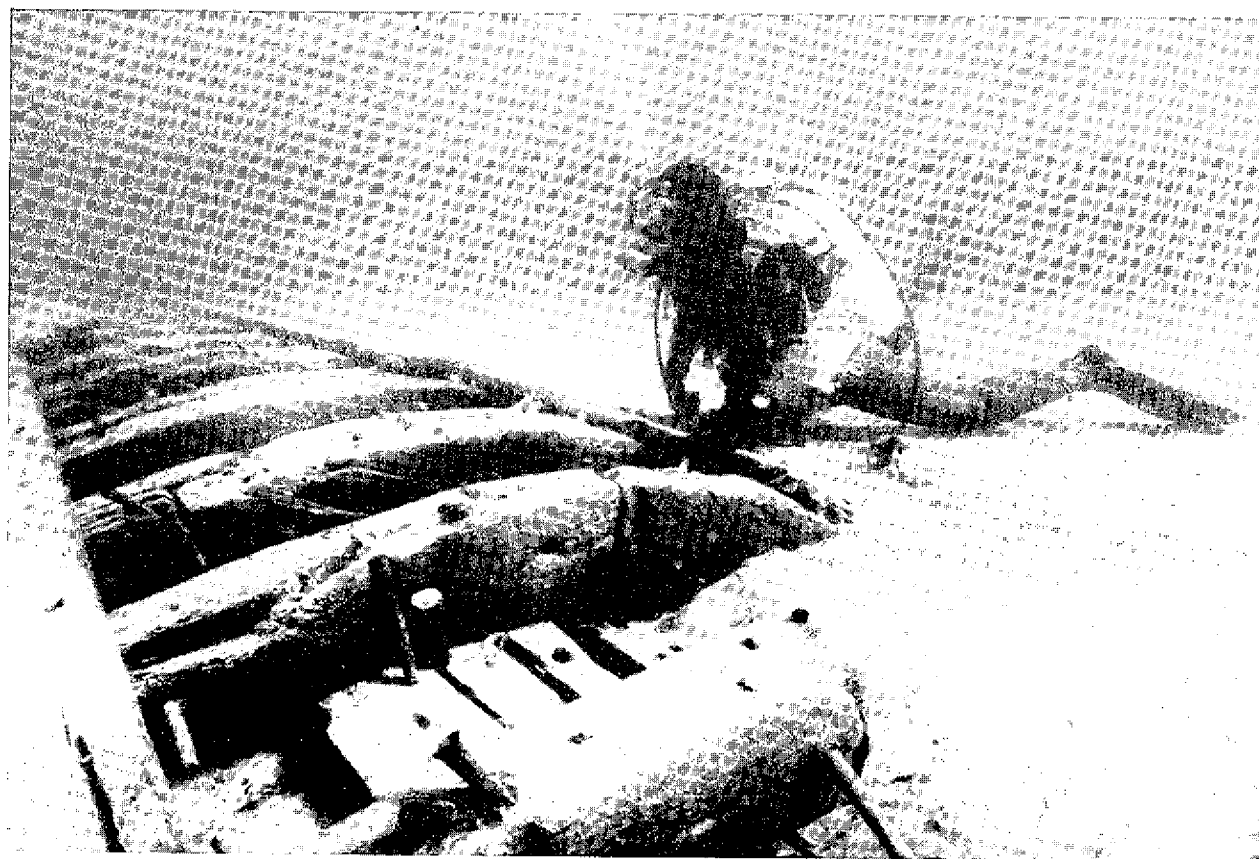
Plate 14: Park Ranger Elen Maurer examines a large section of outboard up port side which broke above the turn of the bilge. Fasteners, frames, hull and ceiling planking are exposed. Photo by Joe Strykowski.

The combined length of the port side sections, which are exposed on the site, is 84 feet 4 inches. This represents just over 40% of the ship's port side. Deep sand and limited time on site prevented additional testing on the port side of the vessel to determine whether there is additional port side present on the site.
